# UNDERWATER BRIDGE INSPECTION REPORT

STRUCTURE NO. 49528

CSAH NO. 26

MISSISSIPPI RIVER

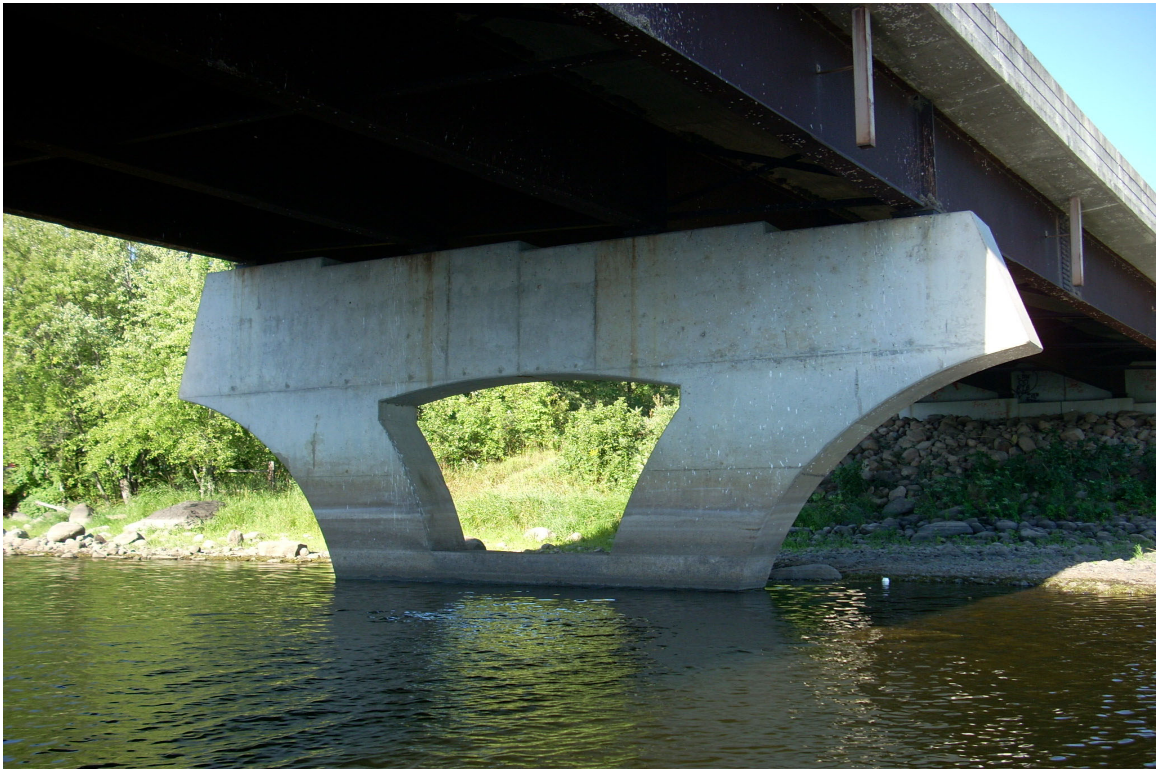
Photograph 2. View of Pier 1, Looking Southwest.

- (C) An area of impact damage was observed on the southwest corner of the upstream column of Pier 1 at 2 feet above the waterline (top of webwall). The impact damage was 1 foot high, 4 inches wide, with 1 inch of maximum penetration with no exposed reinforcing steel.

- Area of impact damage on the southwest corner of the upstream column of Pier 1 at 2 feet above the waterline (top of webwall). The impact damage was 1 foot high, 4 inches wide, with 1 inch maximum penetration with no exposed reinforcing steel.

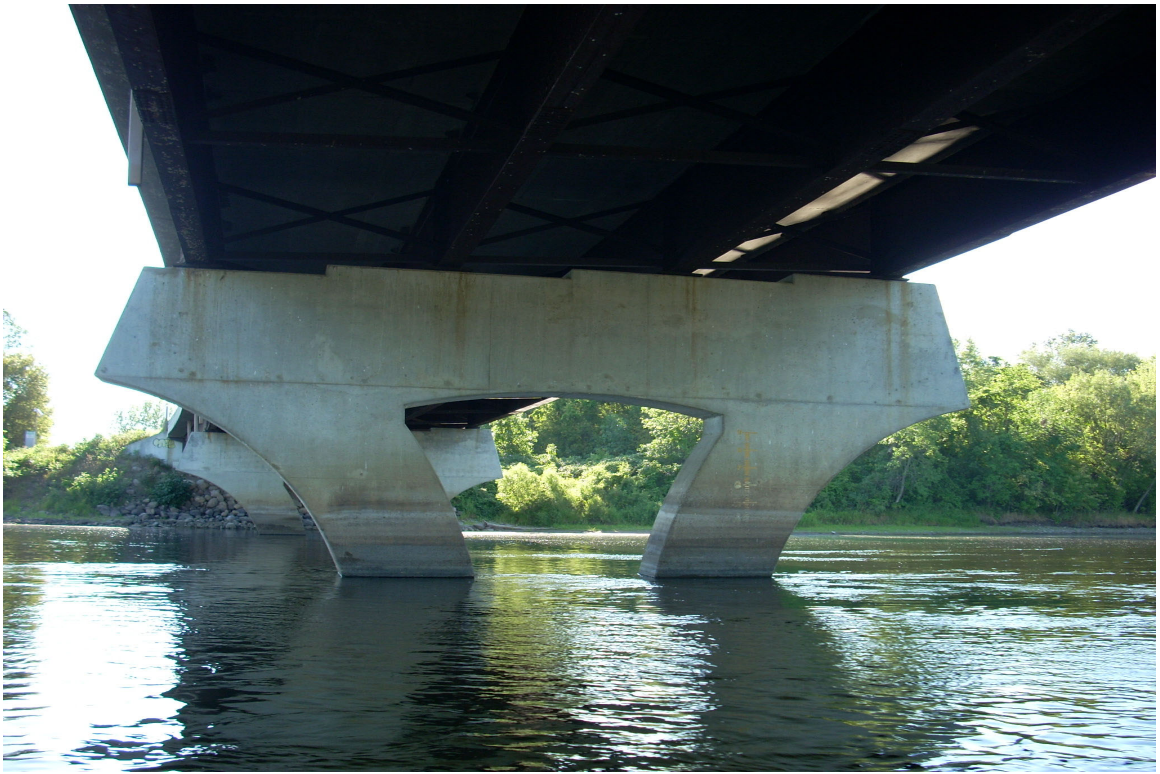
Photograph 3. View of Pier 2, Looking East.

- (A) A poorly formed construction joint was observed at approximately 2.5 feet above the channel bottom at Pier 2. The upper portion of the joint overlapped the lower portion by 1/2 to 1 inch.

- (D) Steel construction debris consisting of a 5 foot long W-section was lying on the channel bottom adjacent to west side at midpoint on Pier 2.
- (E) The top of the webwall at Pier 3 was delaminated with a maximum penetration of 1/2 inch with no exposed reinforcing steel. The concrete below the delamination was rough but sound.

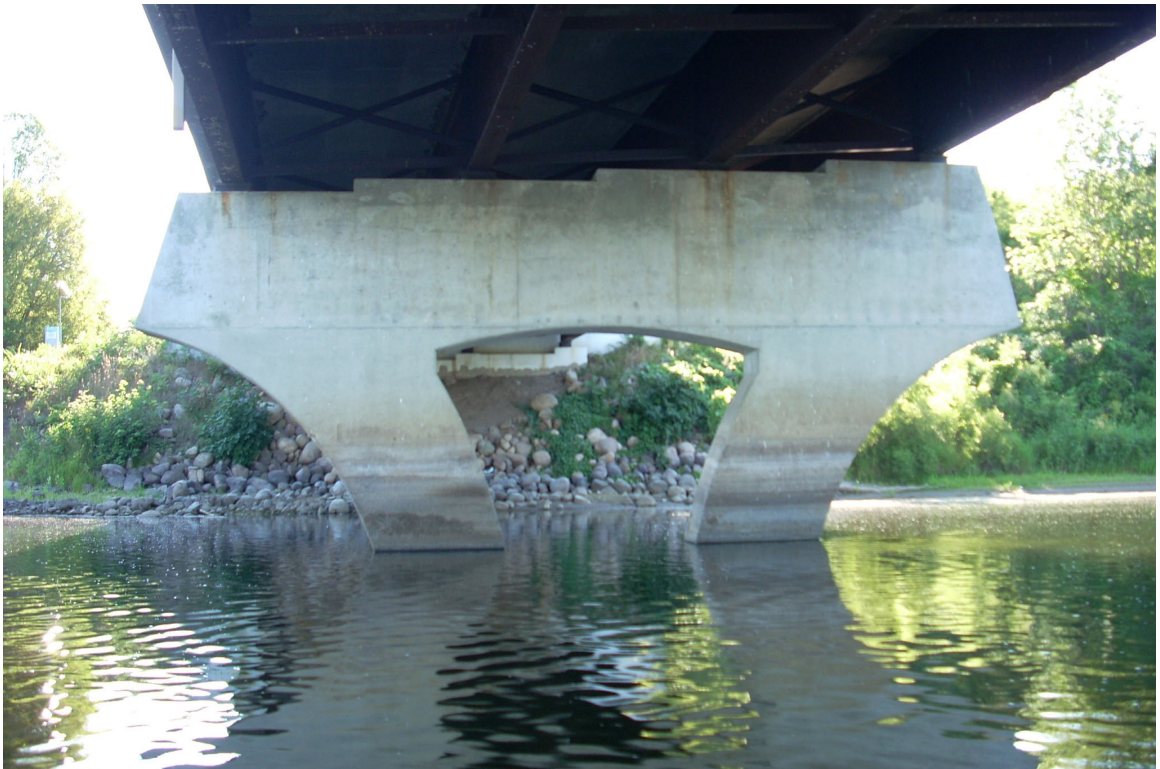
Photograph 4. View of Pier 3, Looking East.

- The top of webwall at Pier 3 was delaminated with a maximum penetration of 1/2 inch with no exposed reinforcing steel. Concrete below the delamination was rough but sound.

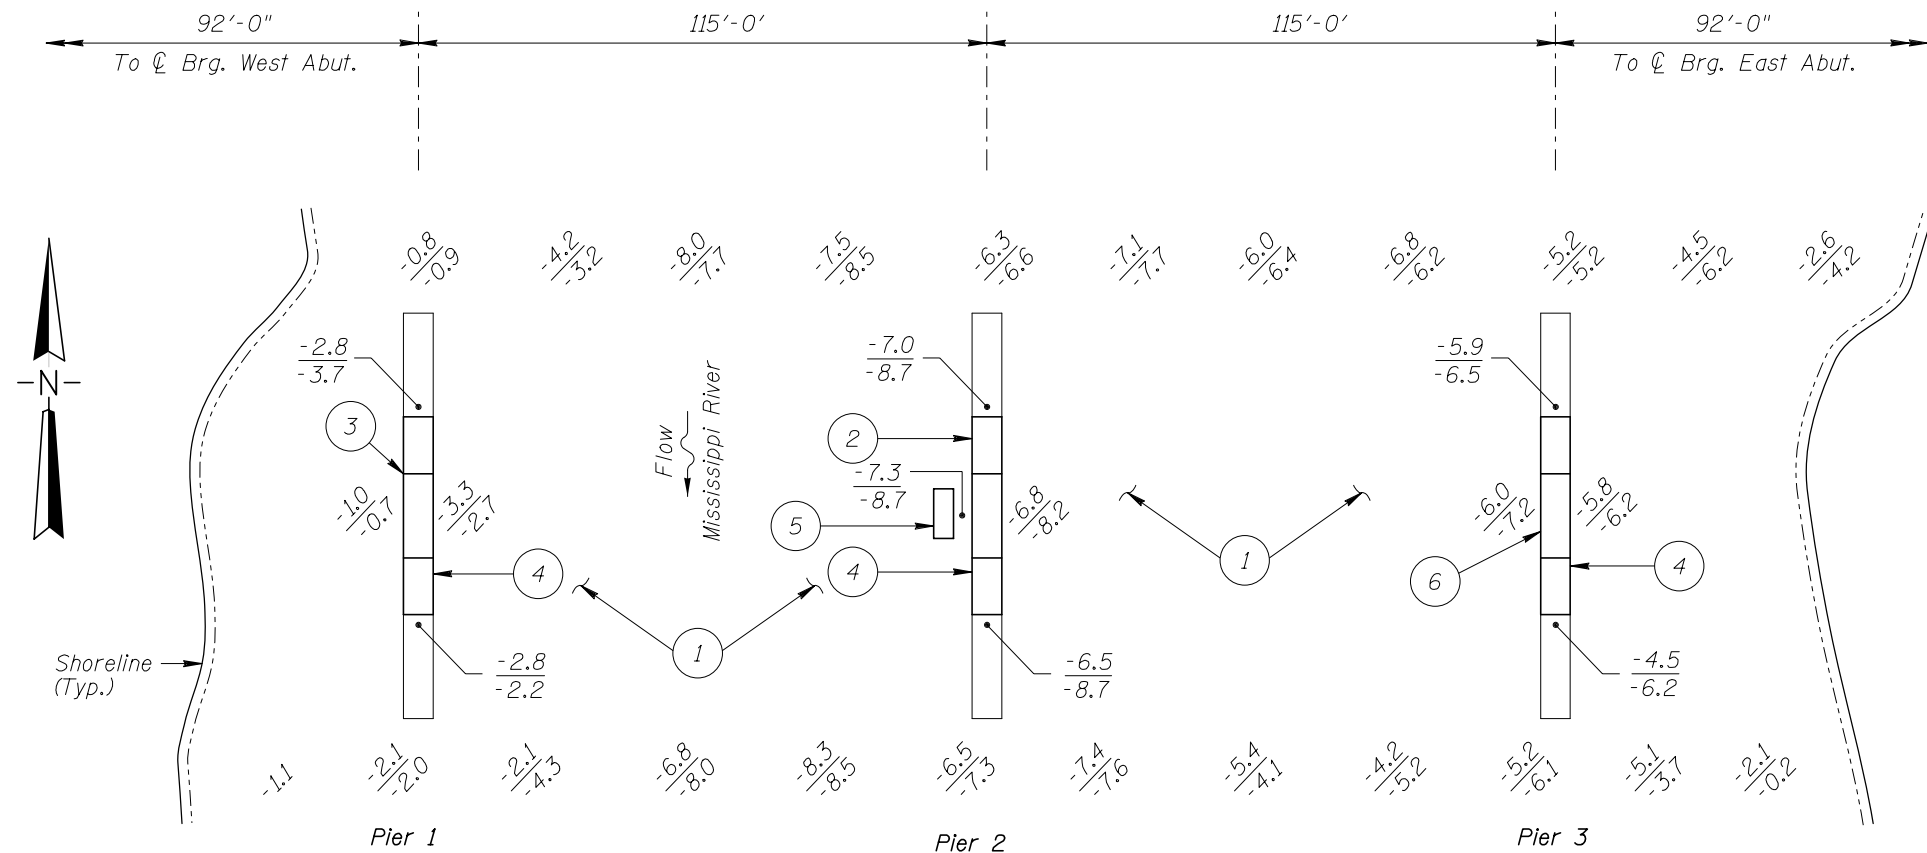
Drawn By: PRH	<b>COLLINS ENGINEERS</b> 123 North Wacker Drive Suite 300 Chicago, IL 60606 (312) 704-9300 www.collinsengr.com	Date: AUGUST, 2007
Checked By: MDK		Scale: NTS
Code: 52210079		Figure No.: 1

- The channel bottom material consisted of gravel and up to 12 inch diameter riprap with no probe rod penetration.
- A poorly formed construction joint was observed with the upper portion overlapping the lower portion by 1/2 to 1 inch at approximately 2.5 feet above the channel bottom.

- The concrete surfaces of the piers were typically smooth and sound with random minor areas of poor consolidation with up to 1/2 inch penetration.
- Steel construction debris consisting of a 5 foot long W-section was laying on the channel bottom adjacent to the west side at midpoint of Pier 2.
